On 03/10/2023 the undersigned surveyor Pisano Stefano received the assignment from Mr. Eric Schwartz to estimate the condition of the vessel in question in order to evaluate her purchase.

MODEL: SABRE 38 HARD TOP EXPRESS NAME : [REDACTED]

- **Pre purchase survey**
- **Commercial evaluation**

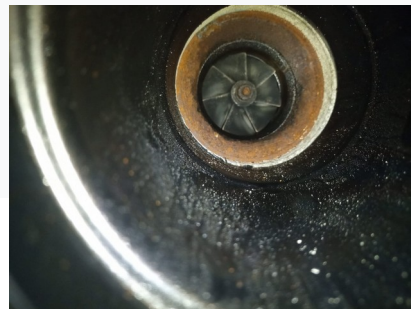
15. Ooze or leaks detected on engine SLIGHT on the right one close to the turbine and in the air filter. Turbines worked properly anyway.

Figura 1: right turbo filter with oil

Currently both engines have no water leaks, an oil leak is found from the tappet cover of the right engine and an ooze is found from the engine oil vapor recovery filter and a slight leak is visible on the inverter oil coolant fitting.

It is therefore advisable to eliminate the oil leaks and replace a hydraulic hose for the right engine inverter and a complete service given the vessel's downtime.

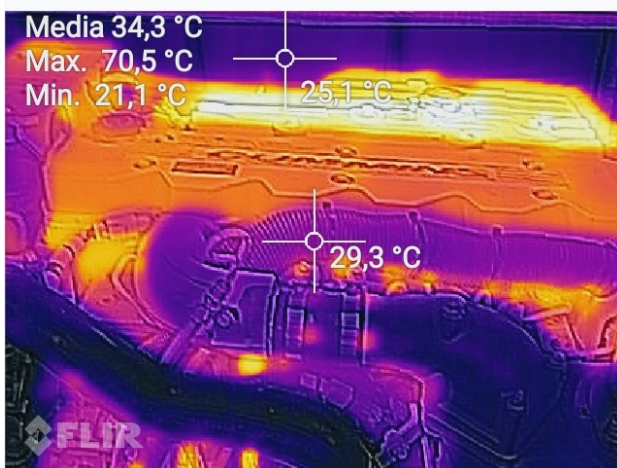
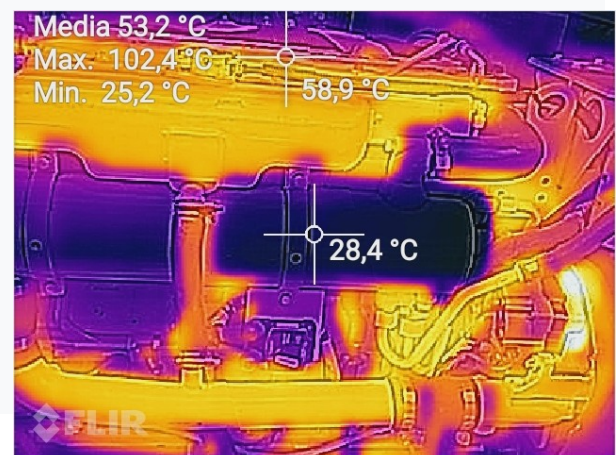
Temperatures close to 80 degrees detected in the hottest points of the engine; The values remained constant during the test, never exceeding the average recorded.
