On 03/10/2023 the undersigned surveyor Pisano Stefano received the assignment from Mr. Eric Schwartz to estimate the condition of the vessel in question in order to evaluate her purchase.

MODEL: SABRE 38 HARD TOP EXPRESS NAME : [REDACTED]

- **Pre purchase survey**
- **Commercial evaluation**

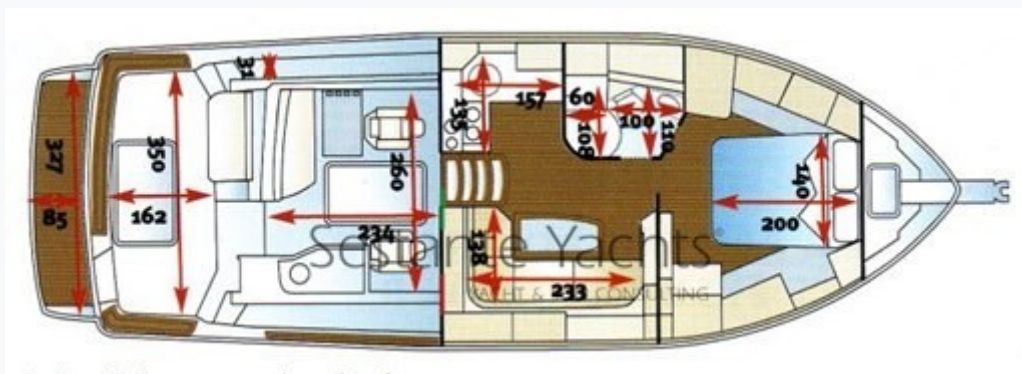
INTERIOR

The vessel was inspected internally following the sea trial, as were all the bilges and systems, to check for any presence of water inside from active or previous leaks. No traces of water were detected in the bilge amidships, nor in the tanks nor in the sump where the suckers of the electric and manual bilge pumps are located.

- The main bulkheads and their bonding were in GOOD condition, no signs of failure, repairs or anomalous torsions were discernible; the bulkheads had intact plywood and no damage.
